White Paper

“Exploring Sustainable Practices for Cold Storage for At-Risk Collections”

Cline Library, Special Collections and Archives, Northern Arizona University

December 22, 2016

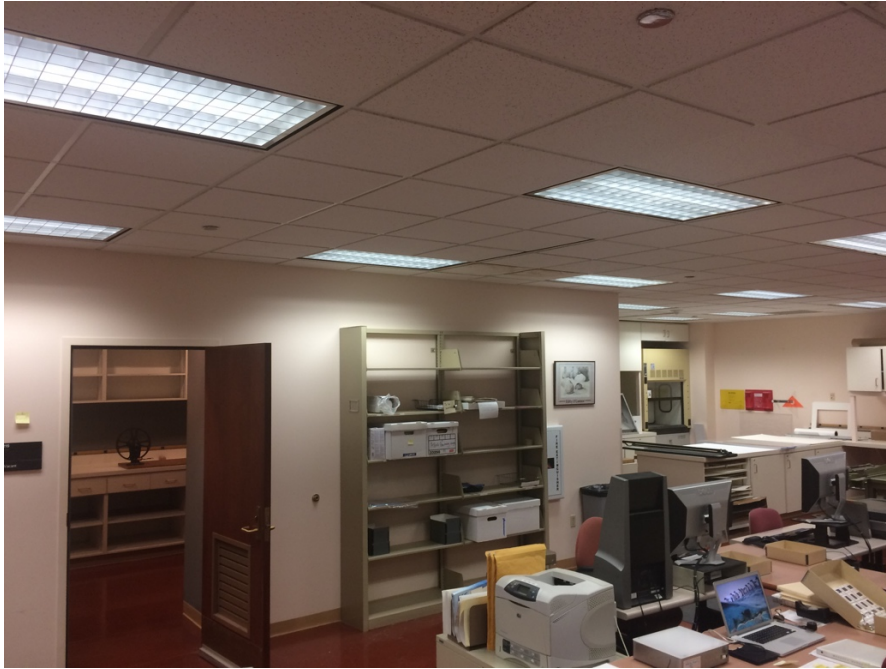
Looking NE in the SCA digitization space. To the left is a former photo developing lab that will be removed as part of tear-down of the space.

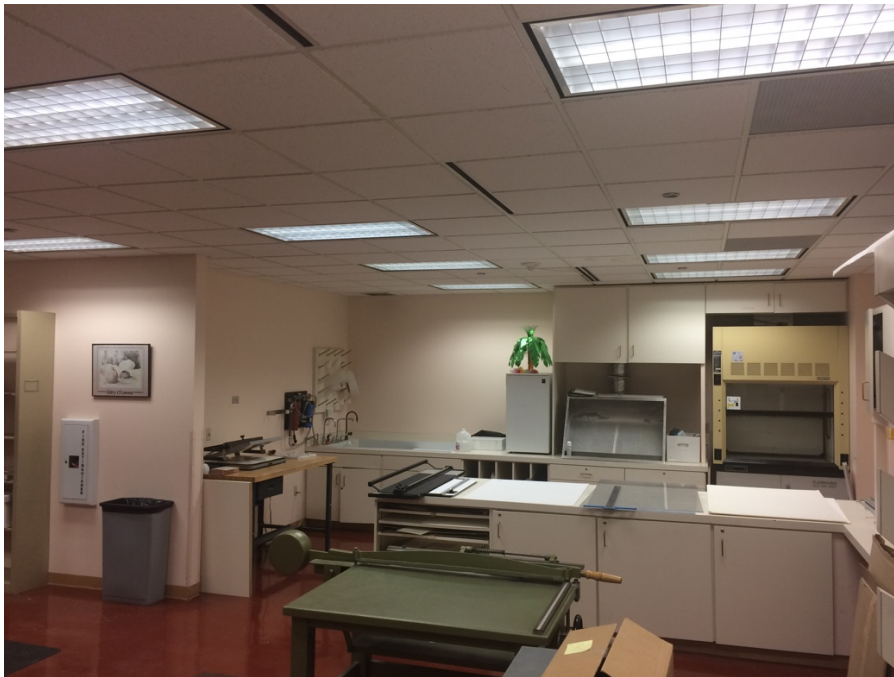
Looking NW in the SCA digitization space. To the right are a fume hood and deacidification unit that will be decommissioned as part of tear-down of the space.

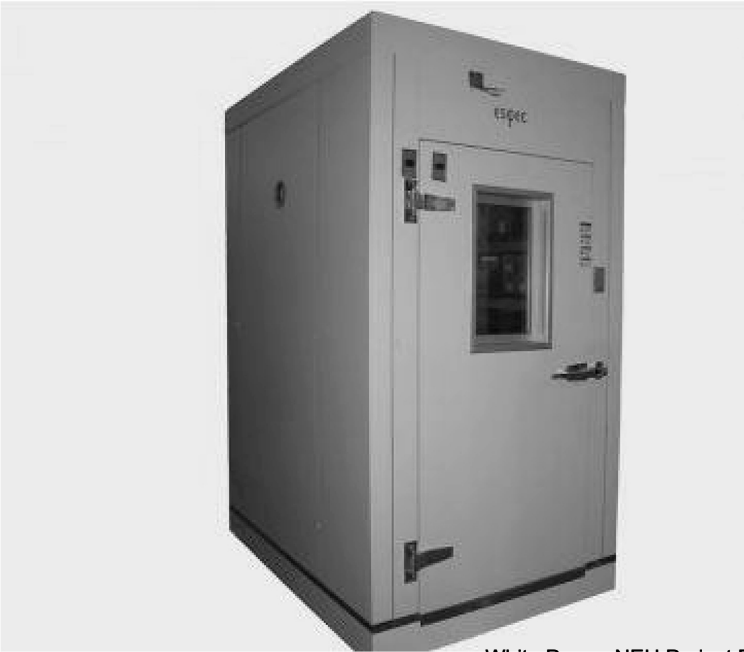
FLOOR PANEL TO BE METAL PANELS ON BOTH SIDES WITH 1/2" PLYWOOD FOR REINFORCEMENT, 3-1/2" FOAM INSULATION CORE (REFER TO MANUFACTURER FOR OPTIONS OF METAL PANELS AND INSULATION)

SHELVING UNITS BASED OFF OF SPACESAVER HIGH DENSITY SHELVES. DIAGONAL HATCH INDICATES STATIONARY SHELVING UNITS. (REFER TO SPACESAVER IMAGES) SHELVING UNITS TO BE PROVIDED AND INSTALLED BY OWNER. FOR REFERENCE ONLY.
